**CANADIAN FORCES
FLIGHT SAFETY INVESTIGATION REPORT (FSIR)**

FINAL REPORT

FILE NUMBER: 1010-CH146420 (DFS 2-2)
DATE OF REPORT: 24 June 2005

AIRCRAFT TYPE: CH146 Griffon
OCCURRENCE DATE/TIME: 182055Z July 2002
LOCATION: 5 Wing Goose Bay, Labrador, Newfoundland (NF)
CATEGORY: "A" Category Accident

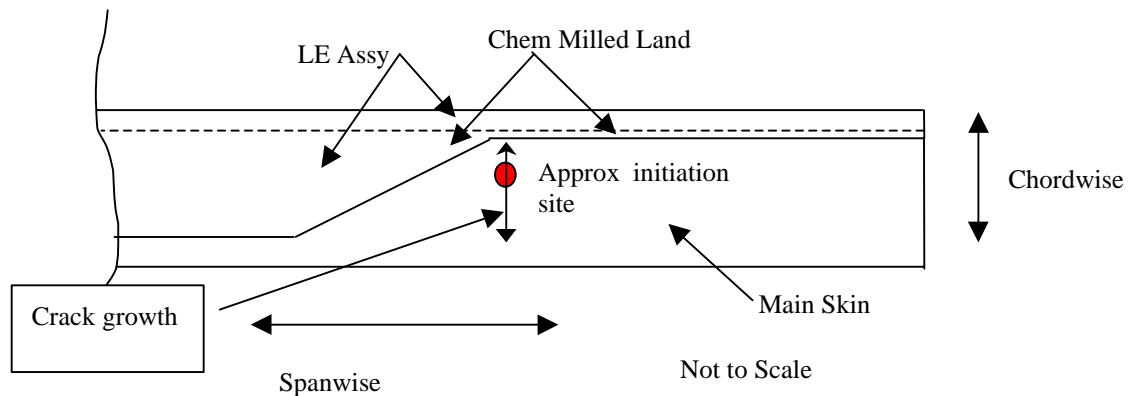
This review revealed the original analyzed points used by the OEM for determining the T/R blade life were not in the same location where the CF fatigue failure occurred. These OEM analysed points (at stations 26 and 16 - 25 inches and 35 inches from the blade tip) are to either side of the CF failure location and are assumed to be the “worst case” condition to arrive at a conservative analysis. The fact that all of the known failures occurred at similar locations which did not coincide with the OEM analysed points is convincing evidence that the analysis did not adequately identify the true critical area. It is important to note that, near the area of the know failures, there is a discontinuity of the blade structure.

Note: Chem Milled Land refers to the area where the chemical etching process is used to change the thickness dimension of the Stainless Steel LE to meet the aluminium material of the blade skin.

Specifically, there is a critical area near the CF failure location defined by a significant change in spar cross section. The structure of the leading edge becomes tapered (chord wise) and the run-out between the tapered portion and the constant cross section is made at a sharp radius creating a local stress concentration (Annex K). The investigation team is concerned that the OEM original design analysis did not predict the failure location. It would seem to be more than coincidental that in service failures have occurred at an area of structural discontinuity.

It should be noted that the area between Stn 30 to Stn 33.5, 21 inches from tip to 17.5 inches from tip, is where the 3 blade failures described in section 2.1.10 occurred. Further, the FAA SAIB mentioned in section 1.17.2 (see Annex S) noted that 5 blade failures (of 7 total verified similar failures) have occurred in this area and one other is within 2.5 inches of the area.
